LIME STORAGE & FEED SYSTEM #510043

BGRS INC.
HOUSTON, TEXAS

SCALE: 3/8" = 12"
DATE: 12 AUG 99
D-510043-01

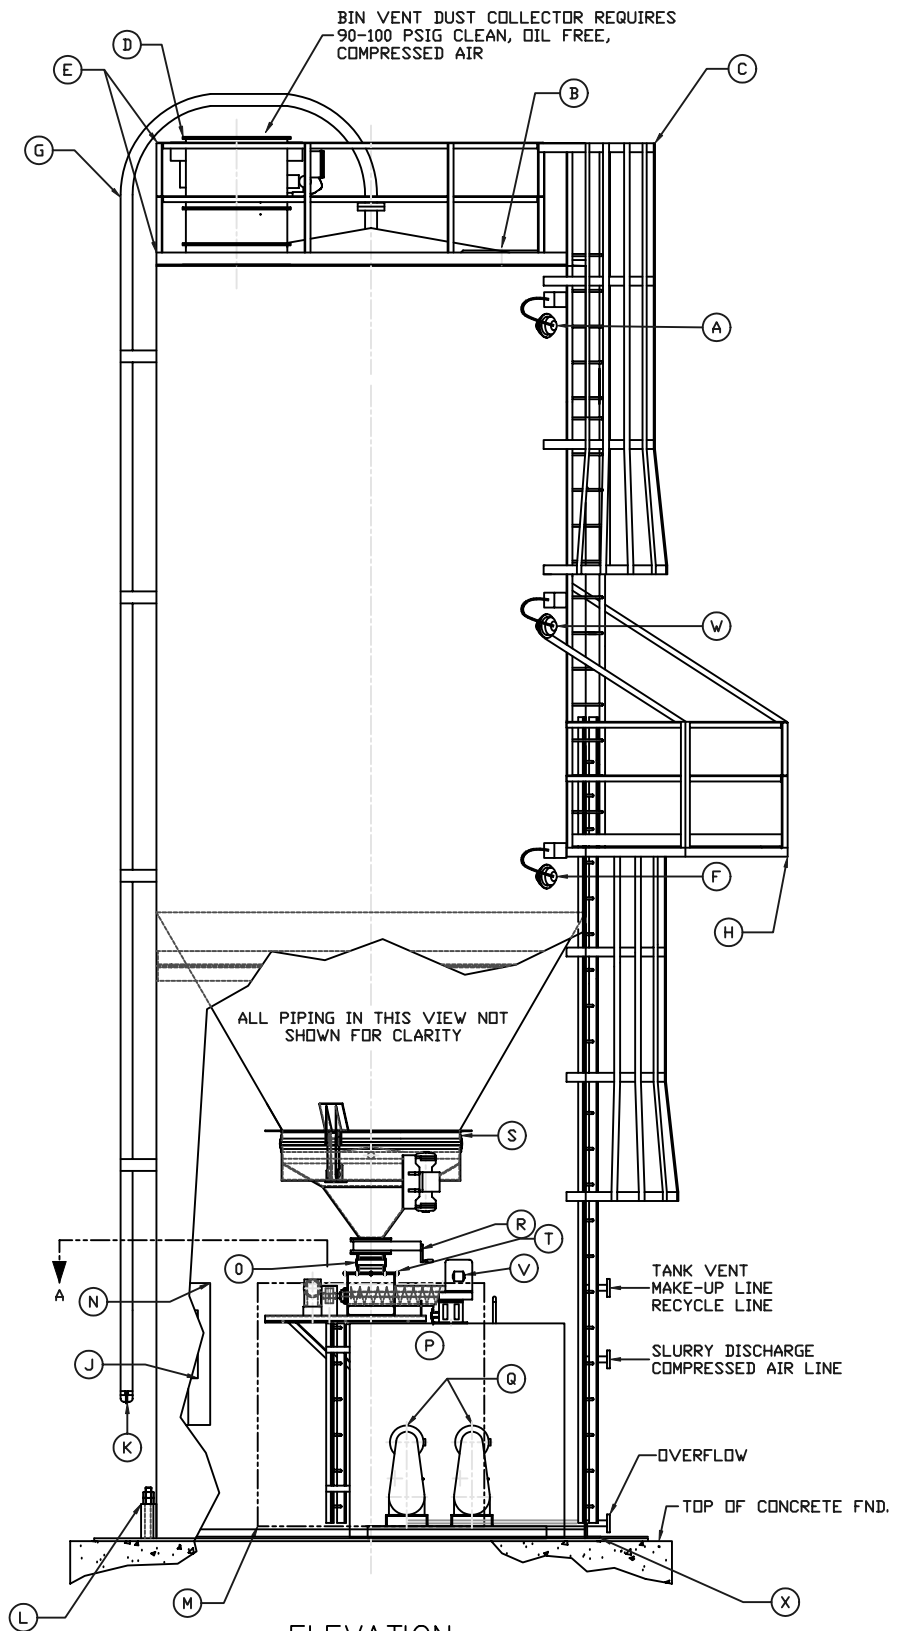
ELEVATION

ITEMS IN THIS VIEW SHOWN OUT OF LOCATION FOR CLARITY, REFER TO PLAN VIEWS FOR ACTUAL LOCATION.
